# Learning from the Field: Concrete Repair and Rehabilitation in Practice Friday 12 December 2025

# THE RESTORATION AND RENOVATION OF THE VELASCA TOWER STRUCTURES AND FAÇADES

Building Info		
Building Name	TORRE VELASCA	
Location	Piazza Velasca 3/5, Milan	
Original Architect & Engineer	BBPR studio & Engineer Arturo Danusso	
Original Contractor	Sogene	
Date	1956-1958	
Current Use	Office, residential

Project Info		
Client	Hines	
Team	CEAS: Structural and Façade project design and construction supervision	
Project Type	Restoration and renovation	
Project Budget	Total: ~ 57 Million € Structures: 3 M € Opaque Façade: 3 M €	
Project Start and End Date	2021 - 2024

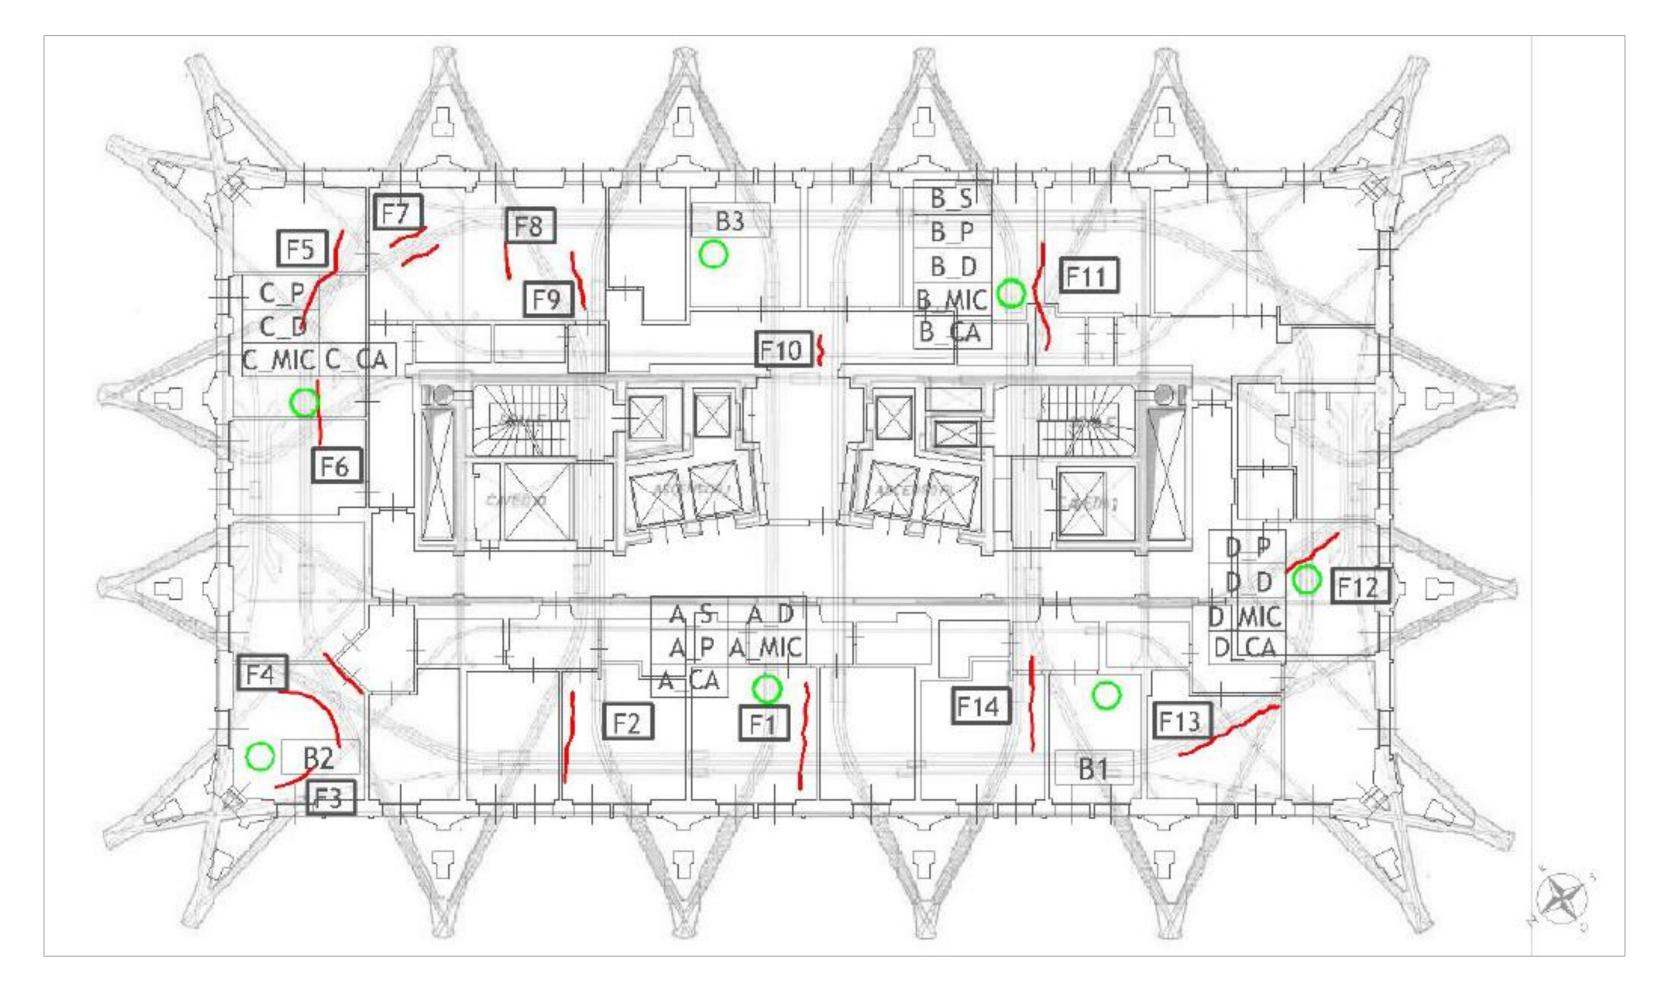
18th floor crack pattern plan

- → Visual inspections
- → Existing crack pattern survey
  - Graphic transcription of the most significant cracks

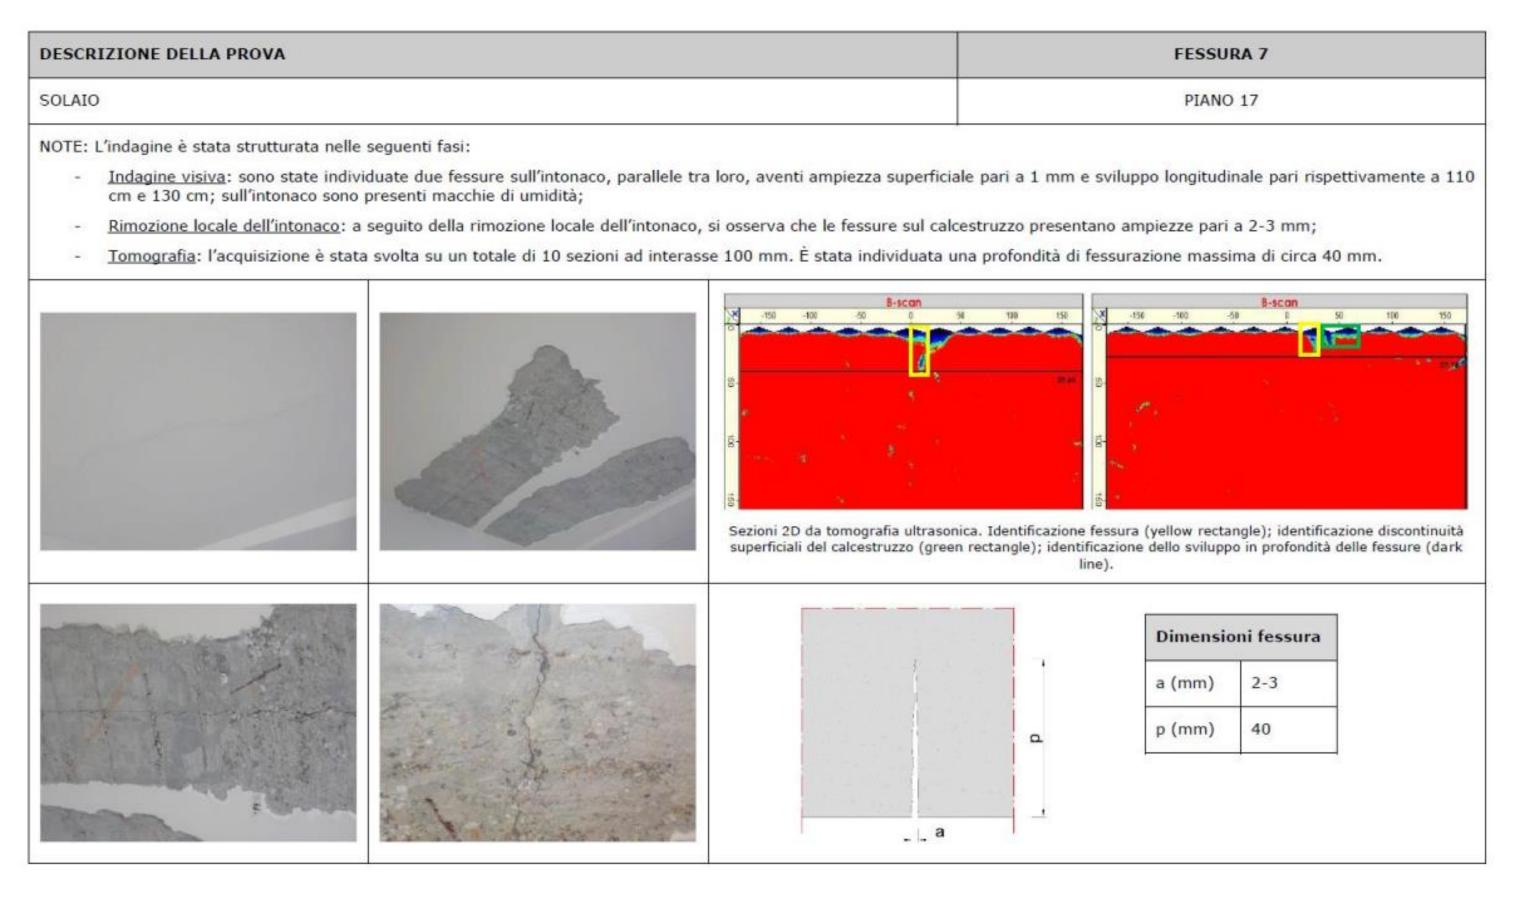
Tomograph survey

- → Non-destructive testing methods:
  - Tomography (evaluate the crack pattern and crack depth)

- Numerous cracks at the slab intrados
- Maximum crack depth = 40 mm

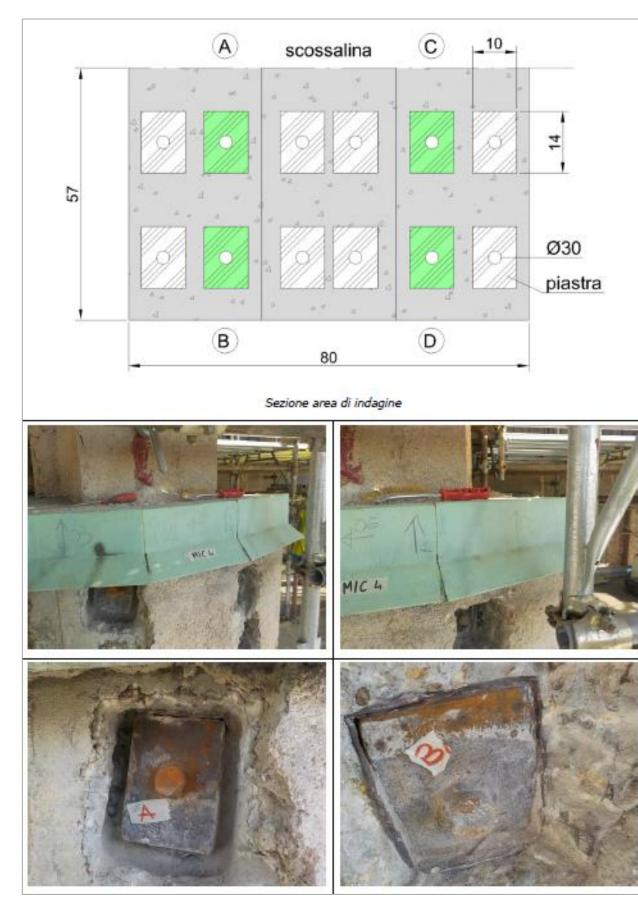
Geometric survey

- Concrete cover thickness
- Plate dimension
- Plates and the top of the rebar present superficial oxidation

DESCRIZIONE DELLA PROVA	MIC 4
TESTATA IN C.A.	PIANO 18
NOTE: E' stato rilevato: zona di ancoraggio in testata composta da Copriferro minimo testa barra pari a 3,5 cm, copriferro piastra pari a 6, Con l'indagine georadar sono state individuate le armature e le piastre d microscassi in corrispondenza delle piastre A, B, C, D (riferimento all'imi e la testa delle barre presentano ossidazione superficiale.	,5 cm. Dimensioni piastra 10x14x5 cm. i ancoraggio; sono stati eseguiti quattro
Ø30	intonaco armato

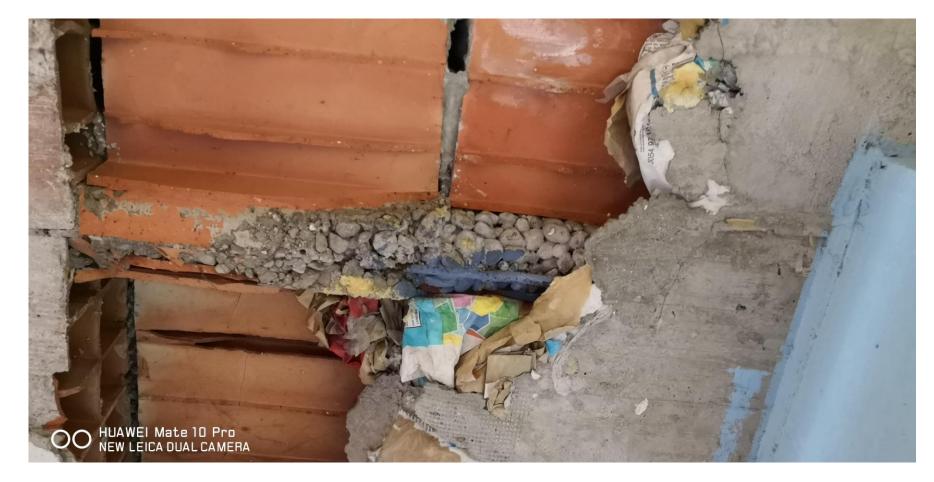
Hollow clay slab degradation

- → Reinforcement structural design:
  - Total demolition and reconstruction
  - Ribbed r.c. slab cast in situ
  - Guarantee fire resistance according to the standards

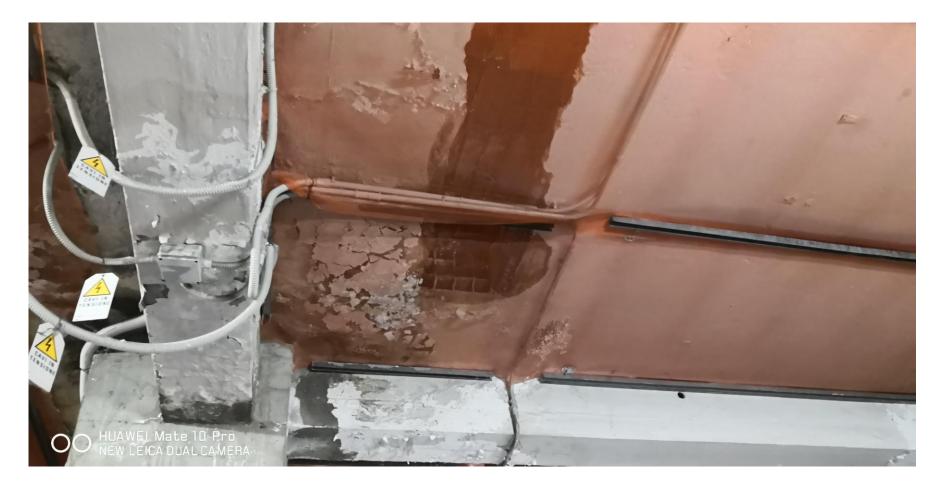
Hollow clay slab degradation

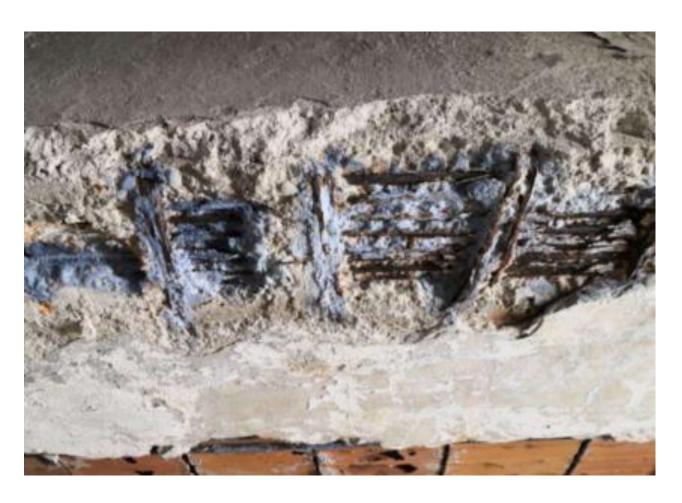
Advanced stage of corrosion of beam rebars

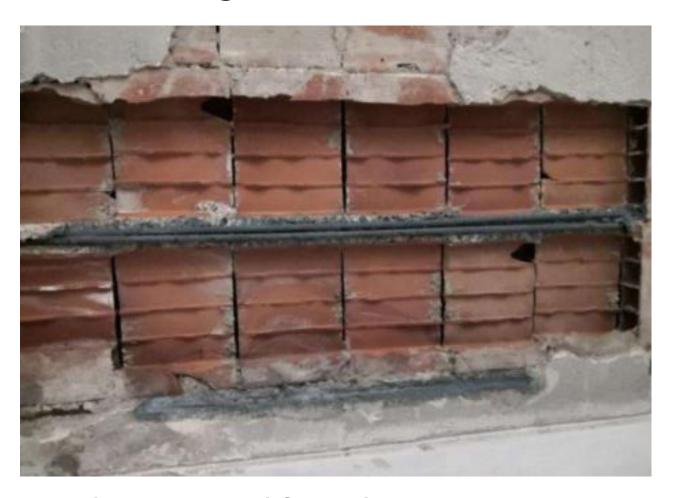
Rebars external from the resistant section

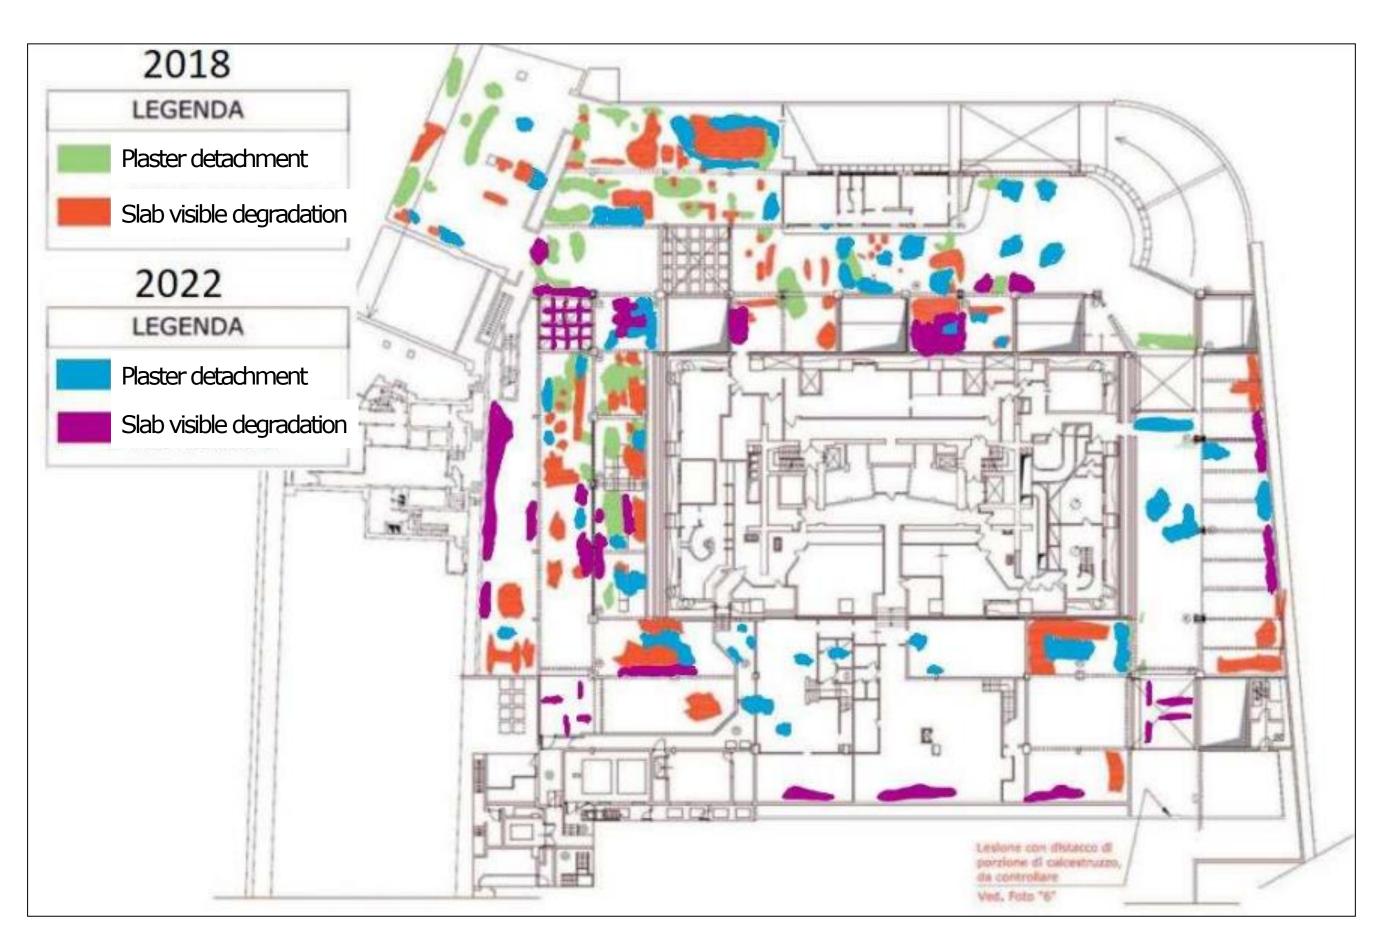
Garage degradation map plan

- → On-site surveys and sampling to define the mechanical characteristics of materials
- → Slab state of degradation mapping and analyses over time
- → Existing structural static verification according to the current Standards
- → Demolition of critical slab portions with structural collapse risk

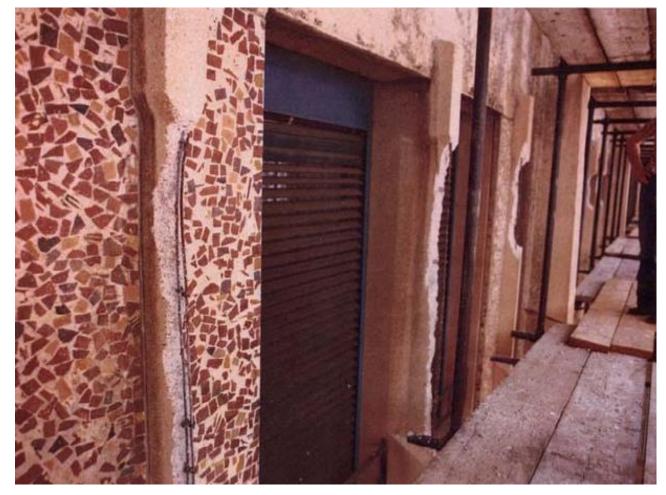
Mortar detachments prefabricated pillars ('70s)

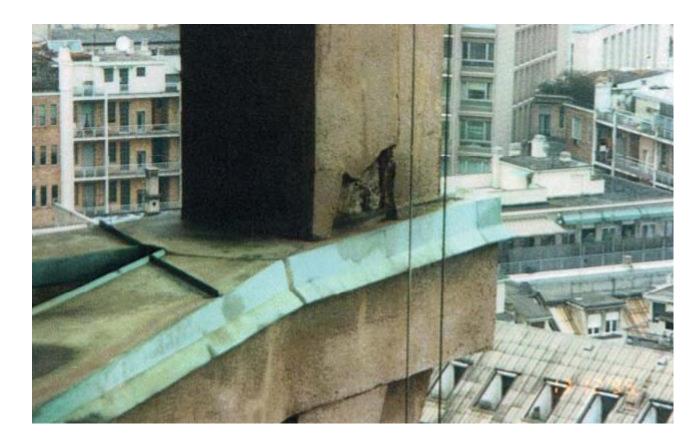
Concrete cover and plaster detachment ('90s)

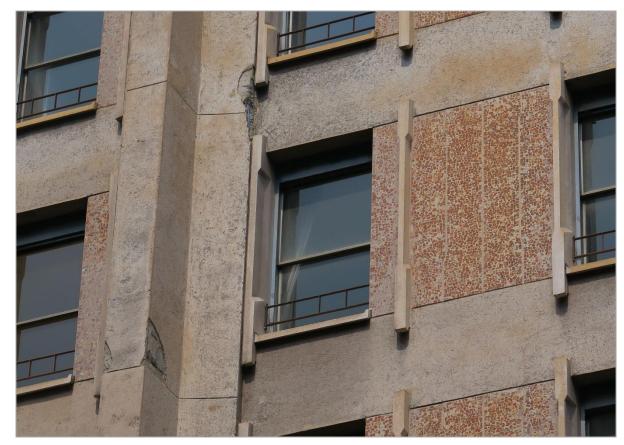
Plaster and concrete cover detachments

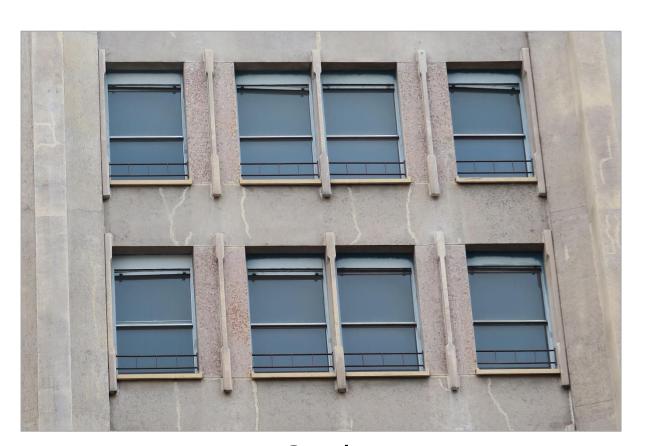
Cracks

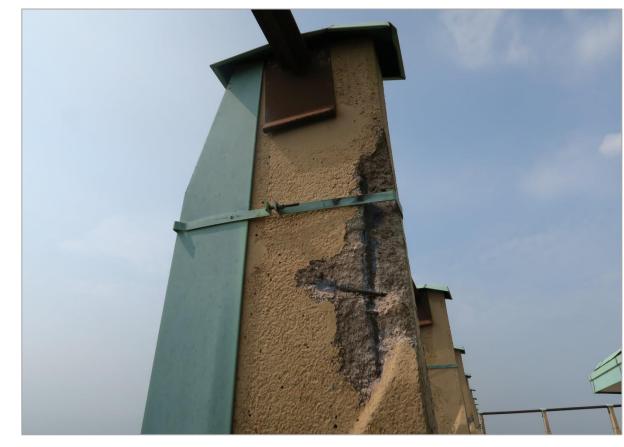
Exposed rebars

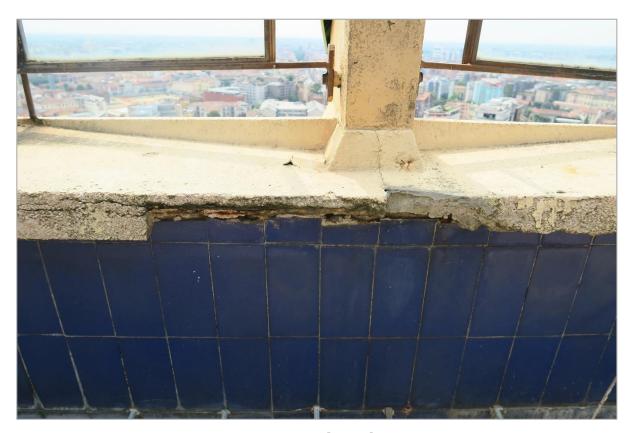
Exposed rebars

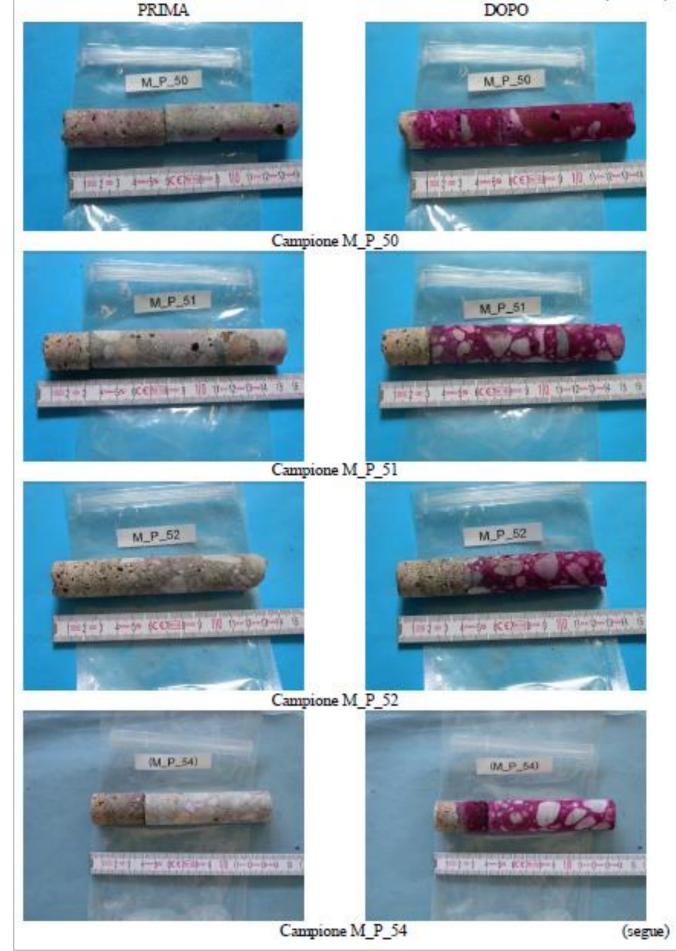
Carbonation tests

- The carbonation process involves 100% of the core samples
- In 40% of the samples the carbonation depth reached the concrete cover
- Possible depassivation of the reinforcing bars
