# Learning from the Field: Concrete Repair and Rehabilitation in Practice Friday 12 December 2025

# THE RESTORATION AND RENOVATION OF THE VELASCA TOWER STRUCTURES AND FAÇADES

Building Info		
Building Name	TORRE VELASCA	
Location	Piazza Velasca 3/5, Milan	
Original Architect & Engineer	BBPR studio & Engineer Arturo Danusso	
Original Contractor	Sogene	
Date	1956-1958	
Current Use	Office, residential

Project Info		
Client	Hines	
Team	CEAS: Structural and Façade project design and construction supervision	
Project Type	Restoration and renovation	
Project Budget	Total: ~ 57 Million € Structures: 3 M € Opaque Façade: 3 M €	
Project Start and End Date	2021 - 2024

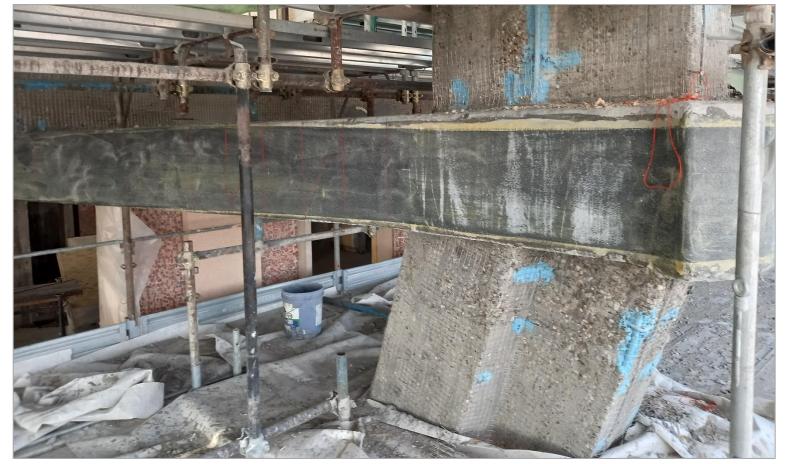
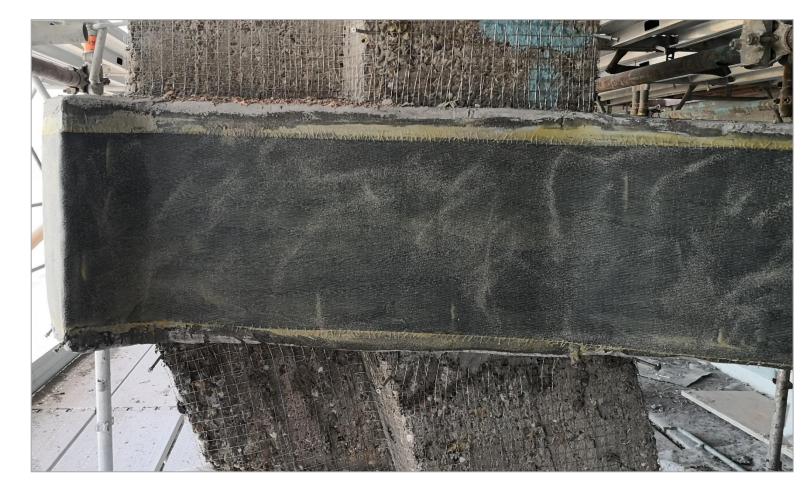
Reinforcement external tie beams

- → Reinforcement structural design:
  - Structural strengthening using carbon fibre fabric (FRP) and epoxy resins to impregnate and bond the fibre
  - Product: Mapei Mapewrap C

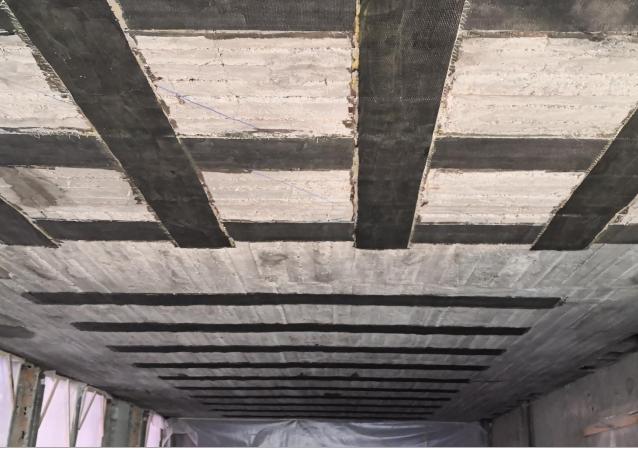
Reinforcement intrados slab

- → Reinforcement structural design:
  - Structural strengthening using carbon fibre fabric (FRP) and epoxy resins to impregnate and bond the fibre
  - Product: Mapei Mapewrap C

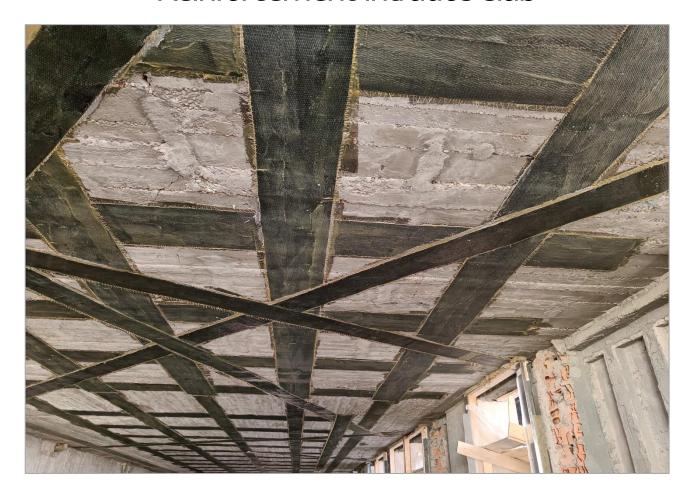
Reinforcement intrados slab and tie beams

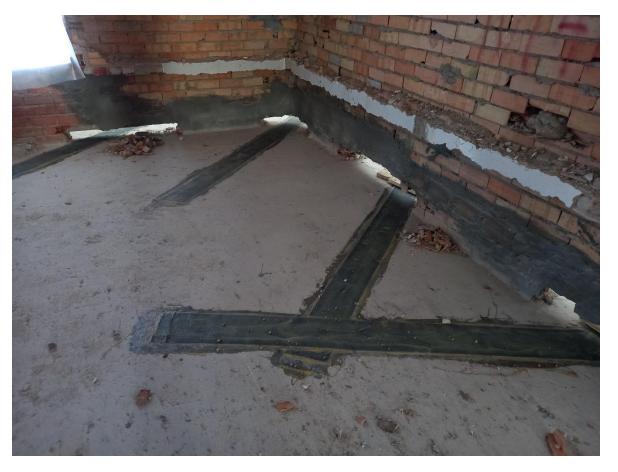
Reinforcement extrados slab

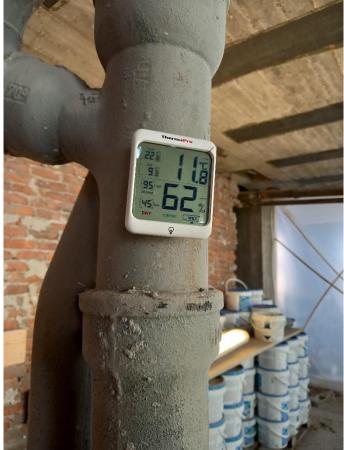
- On-site adhesion tests to validate the structural design assumptions
- On-site application temperature
   T ≥ 10°C
- 30 tests to establish the tensile rupture and the Young modulus
- 3 tests to determine the glass transition temperature

Temperature control

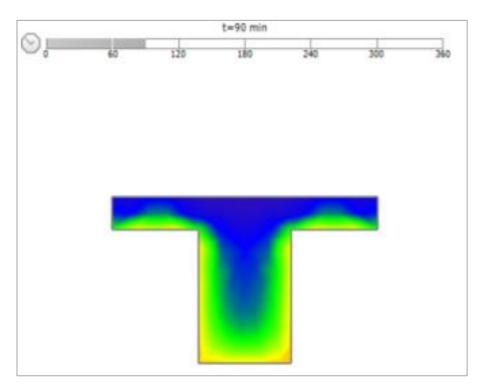
Fire resistance section verification

- → Reinforcement structural design:
  - Total demolition and reconstruction
  - Ribbed r.c. slab cast in situ
  - Guarantee fire resistance according to the standards

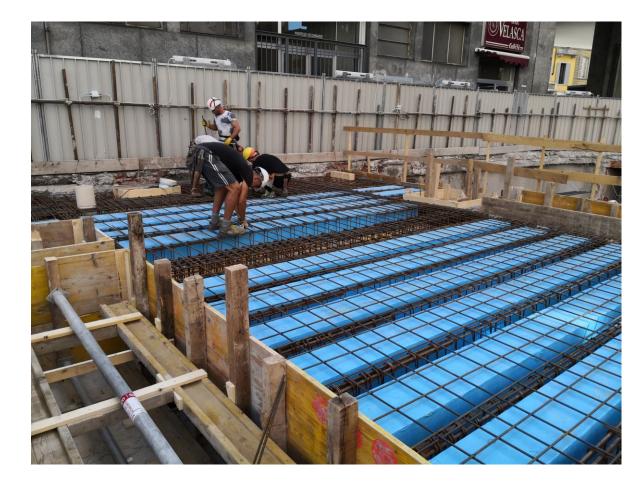
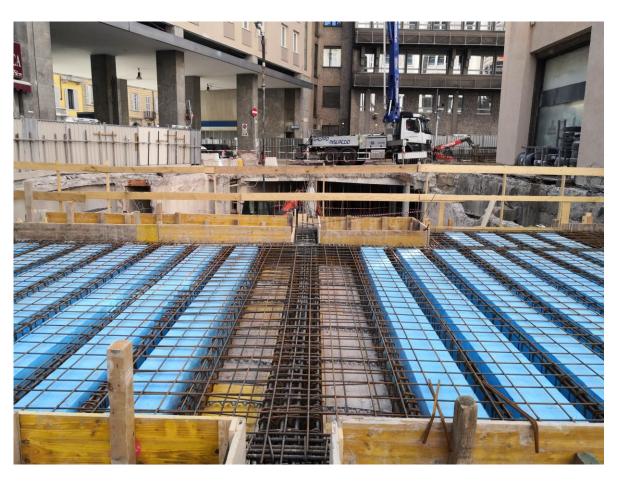
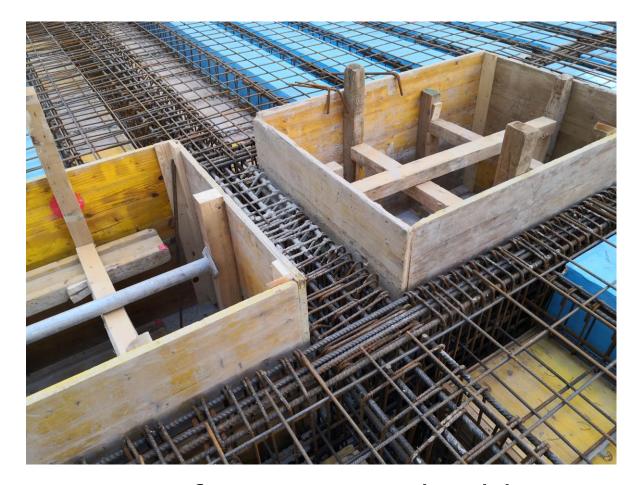
Reinforcement extrados slab

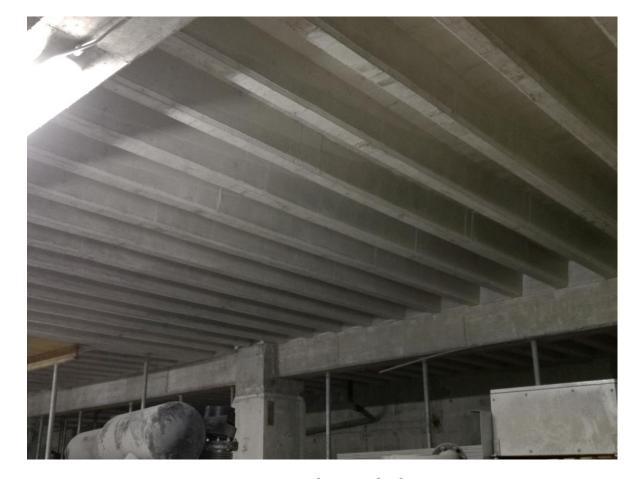
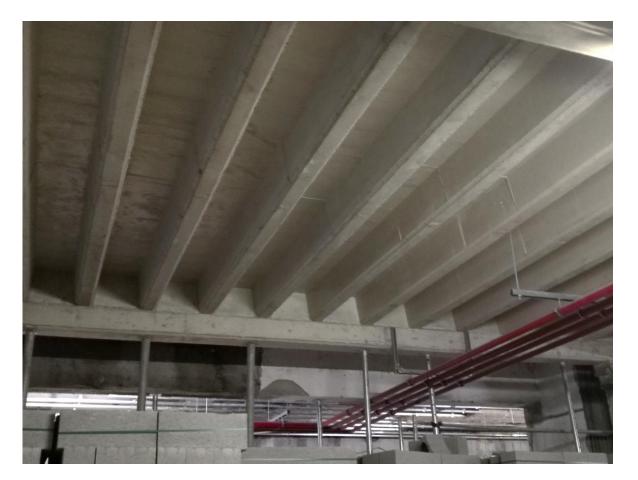
Intrados slab

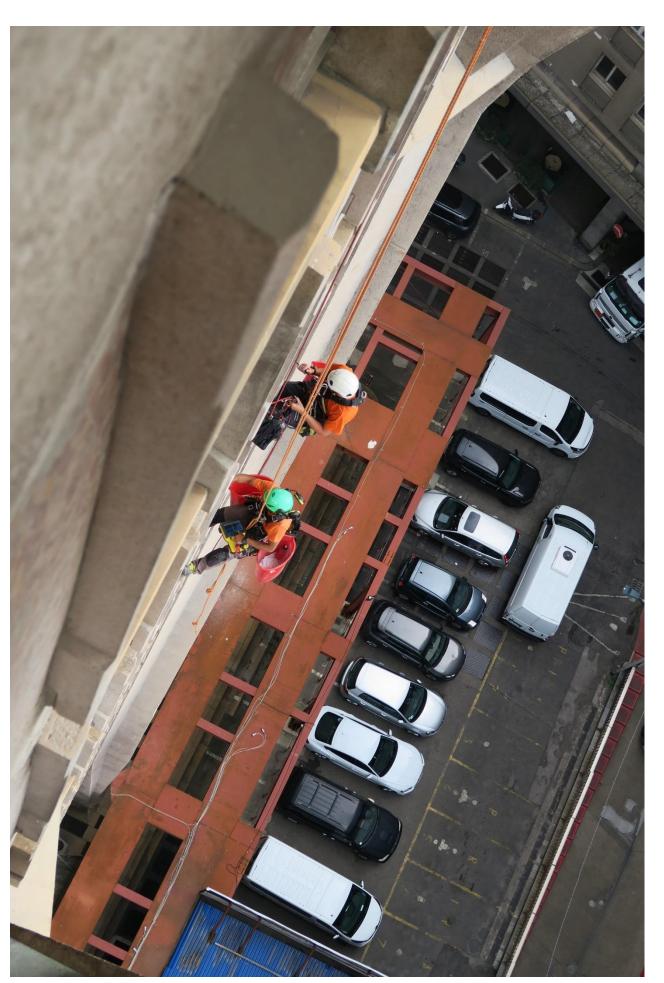
- The carbonation process involves 100% of the core samples
- In 40% of the samples the carbonation depth reached the concrete cover
- Possible depassivation of the reinforcing bars

Rope climbing access technicians survey

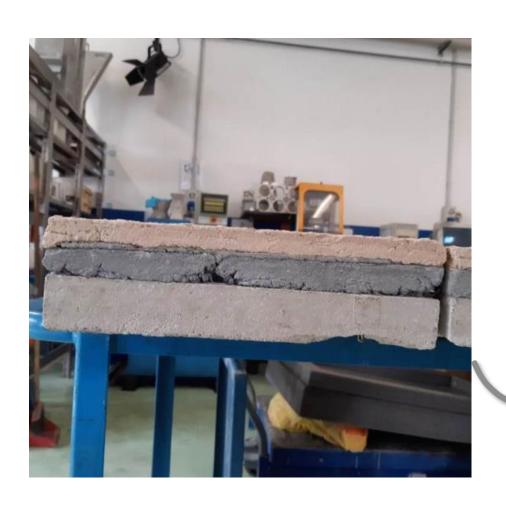
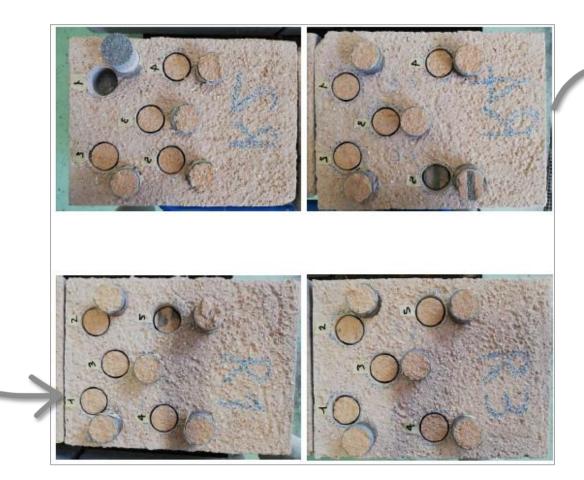
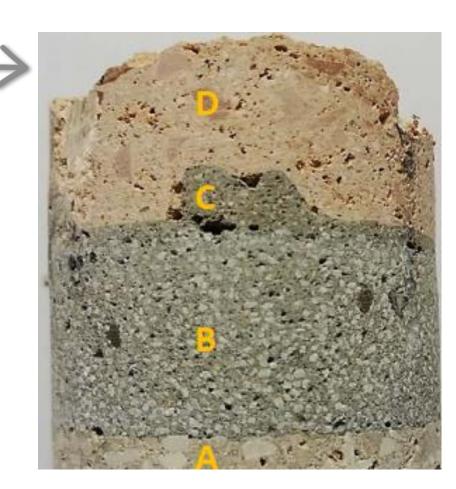
Laboratory tests

- → Laboratory tests:
  - Adhesion tests at the end of curing
  - Adhesion test after thermal/hygrometric cycles
